Dacia Duster
Standard Safety Equipment

2017 ★★☆☆☆

Tested Model	Dacia Duster 1.5 diesel, LHD
Body Type	- 5 door SUV
Year Of Publication	2017
Kerb Weight	1303kg
VIN From Which Rating Applies	- all Dusters
Class	Small Off-Road

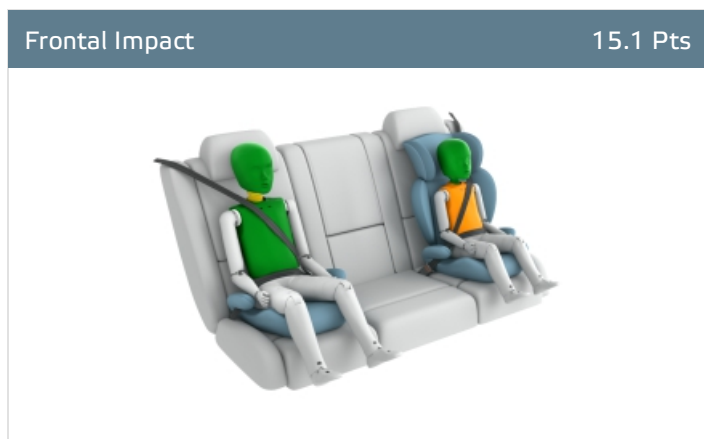
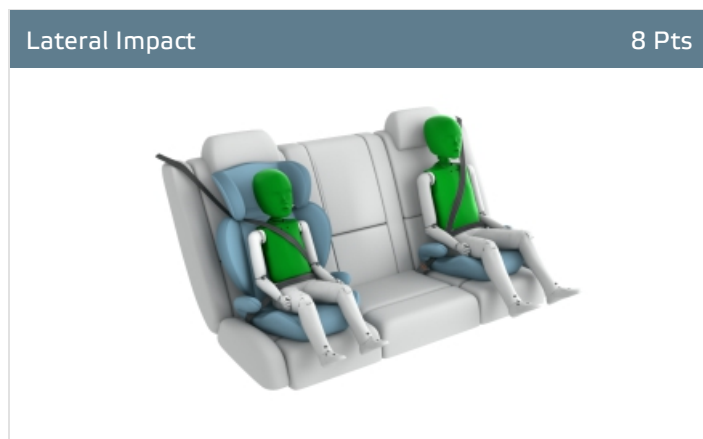
Crash Test Performance based on 6 & 10 year old children

Restraint for 6 year old child: *Romer KidFix XP*
 Restraint for 10 year old child: *Graco Booster*

In the frontal offset test, dummy readings in the 6 year dummy indicated marginal chest protection but, otherwise, protection was good or adequate for both dummies. In the side barrier test, protection of all critical parts of the body was good for both child dummies. The front passenger airbag can be disabled to allow a rearward-facing child restraint to be used in that seating position. Clear information is provided to the driver regarding the status of the airbag and the system was rewarded. The marking of ISOFIX/i-Size anchorages in the rear outboard seats did not meet Euro NCAP's requirements so the installation check of all such restraints is indicated as a partial fail, although the restraints could be installed and accommodated in the car. Universal restraints are not allowed in the front passenger seat so the installation checks are deemed to have failed.
